Case Report

BIOMIMETIC ESTHETIC REHABILITATION OF ANTERIOR TEETH USING THE PUTTY INDEX TECHNIQUE – A CASE REPORT

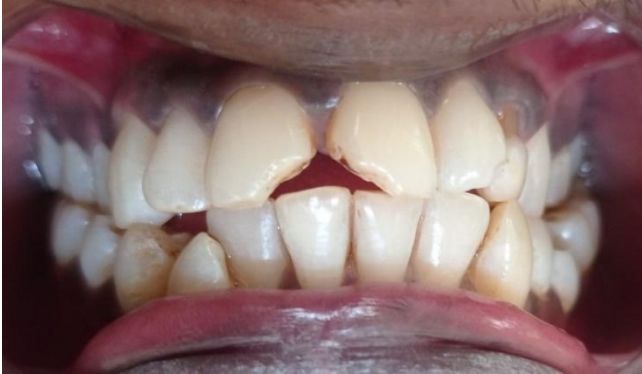
Fig.1 Pre – Operative Photograph

Clinical examination revealed an uncomplicated crown fracture with relation 11 and 21 (Ellis class II fracture) involving only enamel and dentin. Additionally, spacing was also observed between 11 and 21 (1mm) (Fig.1). Percussion tests were negative. When the tooth was examined with an electric pulp tester to determine its vitality, it responded normally in comparison to the adjacent and contralateral teeth. On radiographic examination of the affected teeth, there was no discernible periapical pathology visible. A direct composite restoration utilizing the putty index technique was designed according to the findings of all of these evaluations.

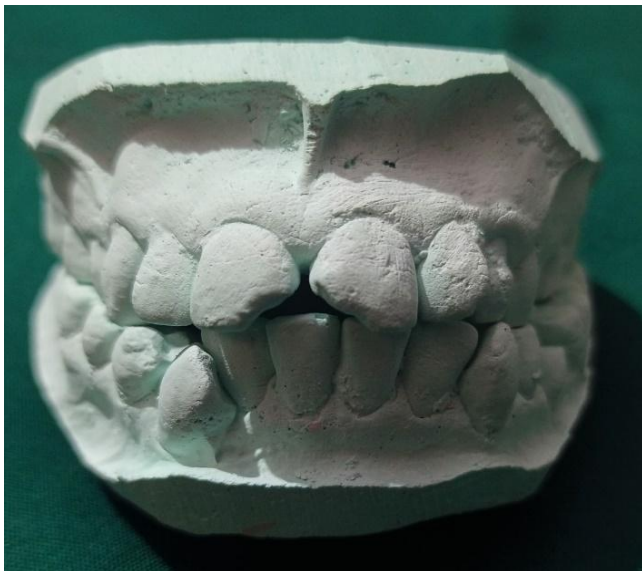
Fig.2 Diagnostic Cast

In the first appointment, after tray selection, preliminary impressions of the maxillary and mandibular teeth were made using dental alginate from which diagnostic casts were obtained (Fig.2). A diagnostic wax up was done on the maxillary cast using mock-up wax (Fig. 3) and a palatal putty index of the concerned region was created (Fig. 4), and any

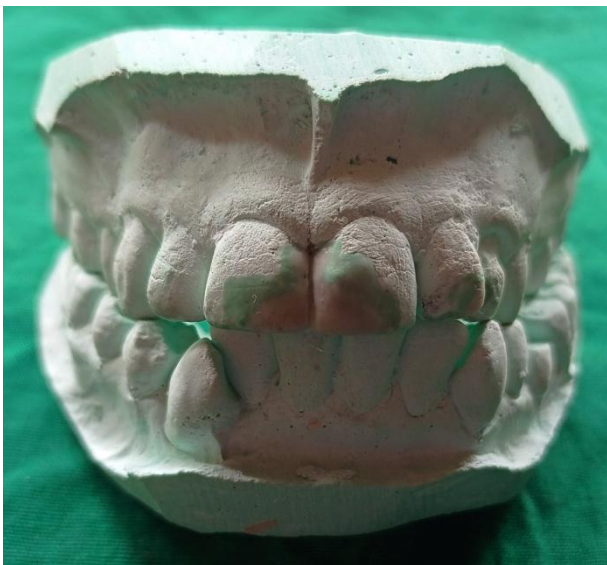
Fig.3 Diagno Stic wax up to Diagnostic wax up

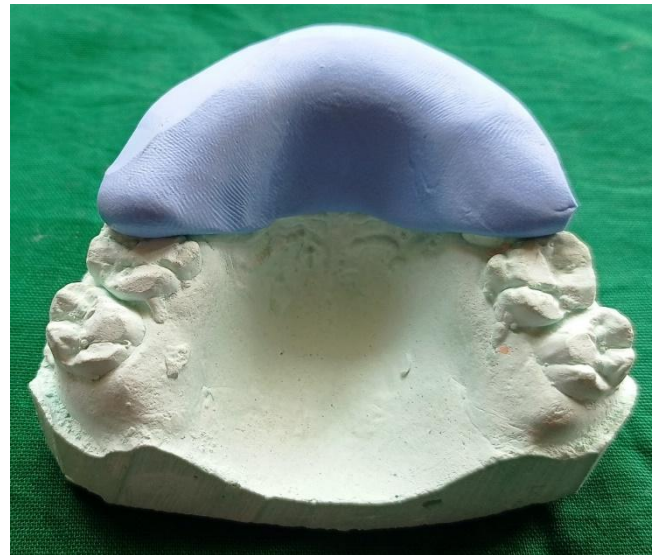
Fig.4 Palatal Putty Index

excess material was trimmed using a scalpel. In future this will be used as a reference guide and to rebuild the palatal surface of the fractured teeth. In the next appointment, the putty index was intraorally verified for fit. The choice of shade was made in the presence of natural light. Bevels were then given on the labial aspect of the fractured tooth 11, 21 to remove unsupported enamel margin and to increase the surface area.

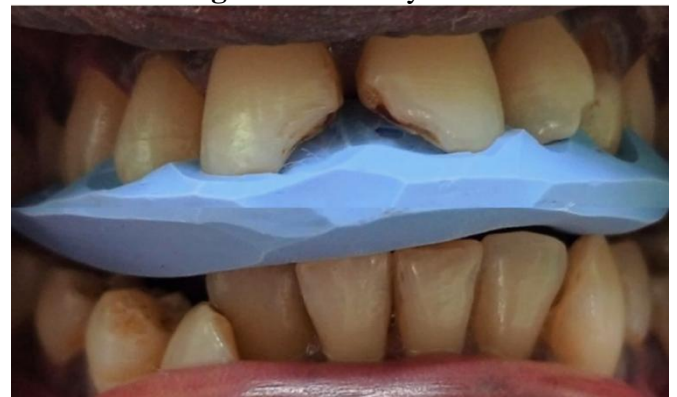
Fig.5 Palatal putty index seated in the mouth

After isolation, standard etching and bonding protocols were followed (Fig.5). The index was removed and composite material (IvoclarvivadentTe- Econom plus, hybrid composite kit) of the selected shade was placed in the palatal portion of 11 and 21 on the index in a thin layer after which it was again placed into the patient's mouth and cured for 30 seconds. After that, the putty index was carefully removed, leaving behind a stiff composite layer attached to the tooth that functioned as a palatal reference guide.

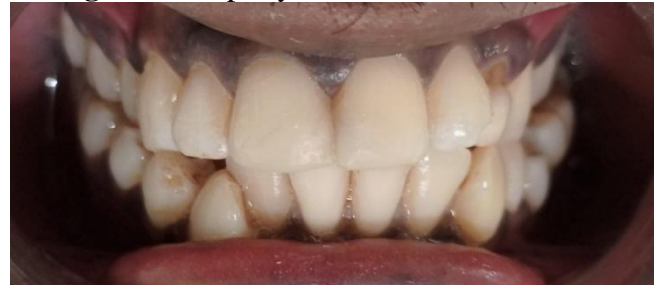
Fig.6 Post Operative View

The tooth was restored by incremental layering of composite material. Mylar strips were used to replicate the mesial contours. To accomplish an aesthetically attractive final restoration and diastema closure, finishing and polishing were carried out utilizing composite polishing kit and paste (Shofu Inc. Kyoto Japan, Prime Dental Aster Compo, respectively) (Fig. 6).
