Research Article

BEHAVIOUR OF REINFORCED CONCRETE STRUCTURES SUBJECTED TO FIRE

Solairajan M*

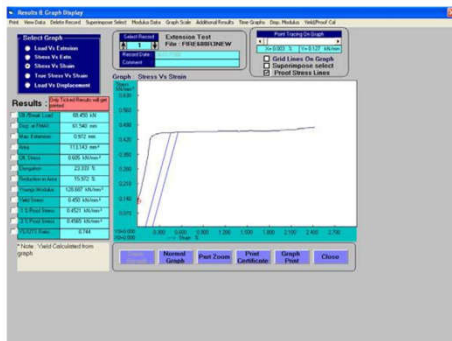
Fig 1 UTM testing setup

The 12mm steel bar is cut to a length of 40 cm and gave a gauge length of 60mm. The specimen is fixed on the machine and the required data on the computer is given. Test is conducted at a load rate of 300 kg/min for all the specimens. An extensometer is fixed to the specimen during the test to read the elongation. The data of the test is noted in computer during the test by default s it is setup. The graph of load versus deformation and load versus elongation is drawn on the computer. After the test all the other parameters like ultimate load, maximum extension in mm, area in mm², ultimate stress, elongation in percent, reduction in in area, young’s modulus, yield stress, .1% and .2% proff stress and many other parameters can be observed.

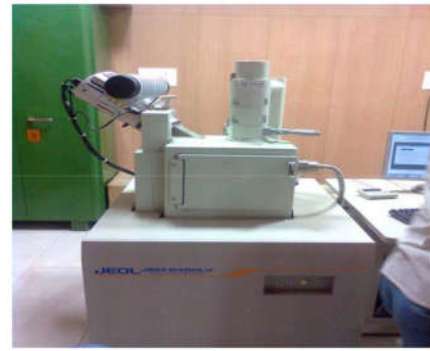
Fig 2 Setup of SEM

Scanning Electron Microscopy has done by JSM- 6480LV at magnification of 5 microns (x5000) and 10 microns (x1000). The specimens are made in a size of 12mm diameter and 10mm length. Before testing the specimens are to be finely polished in all the edges and neatly cleaned with acetone for the clear view of the grain size and grain structure.

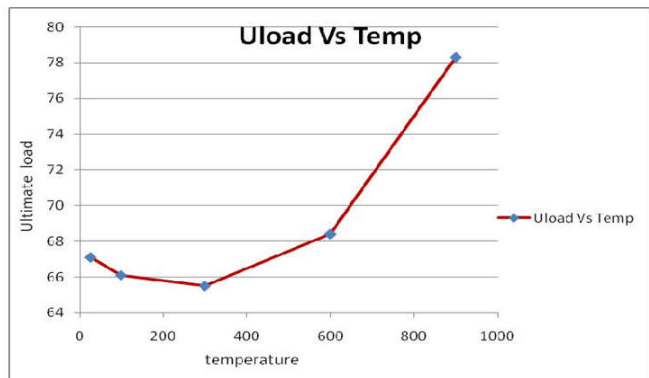
Fig 3 Temperature vs ultimate load

From the graph it can be observed that the ultimate load initially decreases from and then gradually increases, this happens due to the microstructure of the bar. For high temperatures the grain size decreases.

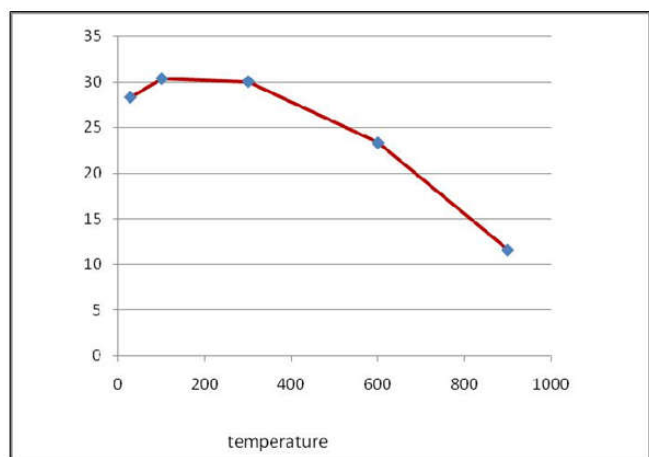
Fig 4 Temperature vs% elongation

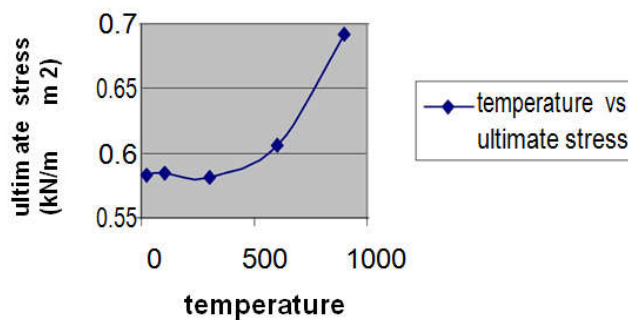
Fig 5 Temperature vs Ultimate stress

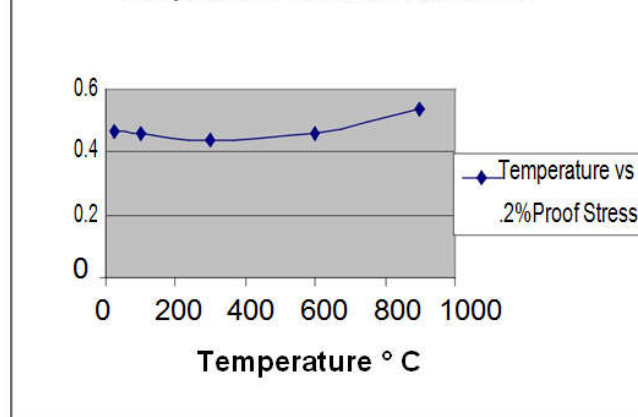
Fig 6 2% Proff stress vs temperature

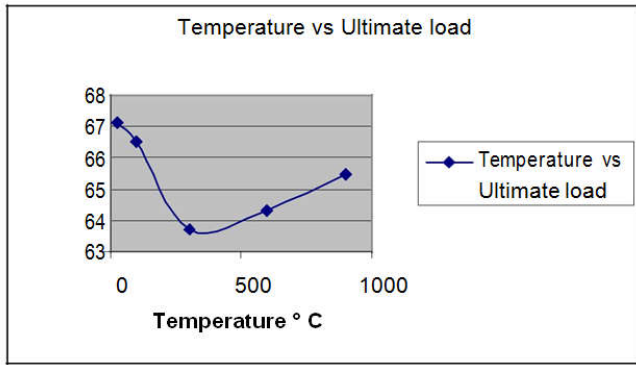
Fig 7 Temperature vs Ultimate load

From the Fig 7, the ultimate load carrying of the specimen was reduced to the specimen before heating.

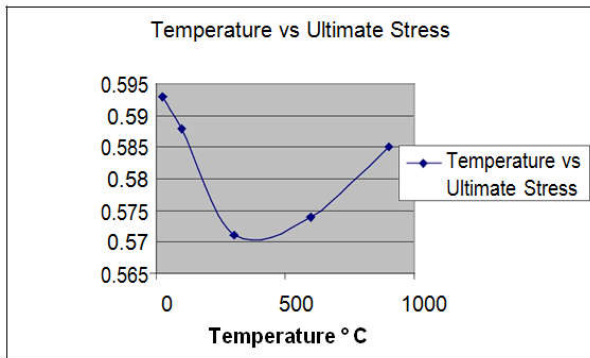
Fig 8 Temperature vs Ultimate stress

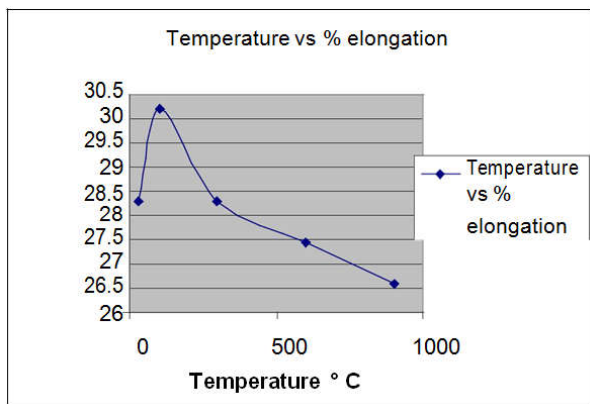
Fig 9 temperature vs elongation

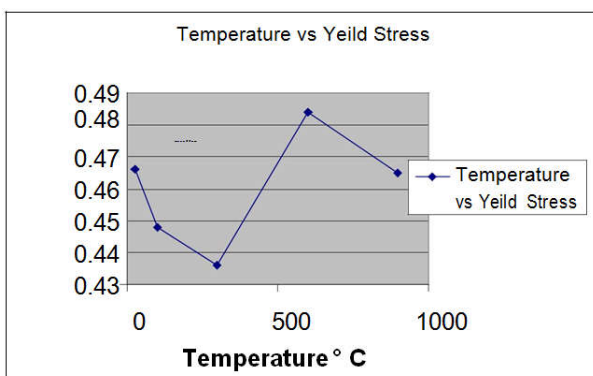
Fig 10 Temperature vs yield Stress

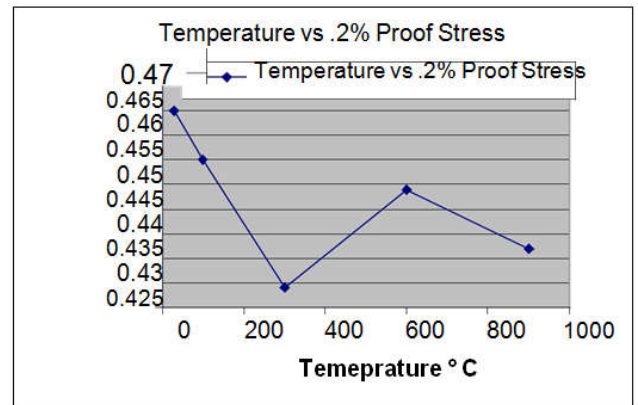
Fig 10 Temperature vs .2% Proof stress
